WatchDog Inspectors

Property Inspection Report

Property address: **SomeStreet, Somewhere.**

Inspection date: **Friday, February 12, 2016**

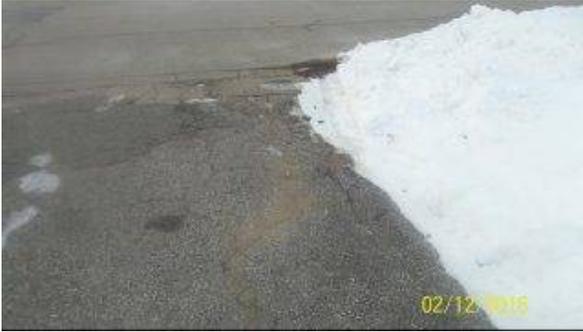
Photo 3-1

Cracks, holes, settlement, heaving and/or deterioration resulting in trip hazards were found in the driveway. For safety reasons, recommend that a qualified contractor repair as necessary.

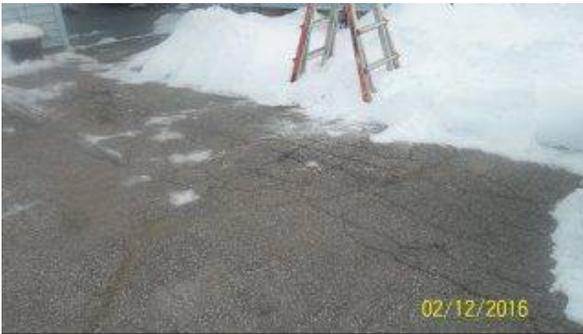
Photo 4-1

The asphalt driveway surface was worn and is prone to developing cracks from water penetration. Recommend that a qualified person reseal the driveway. For more information, visit: <http://www.reporthost.com/?RAD>

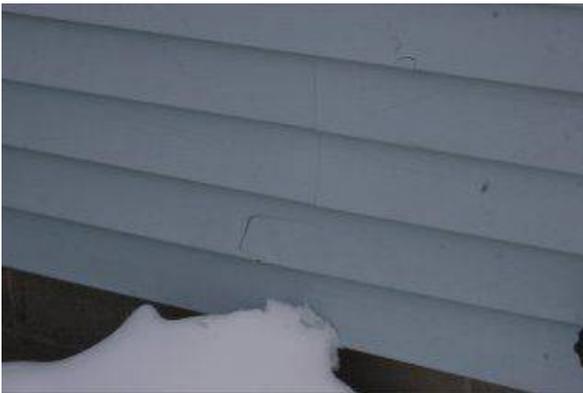
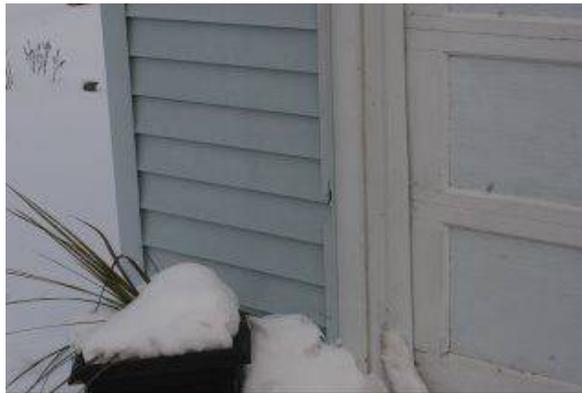
Some sections of siding and/or trim were damaged. Recommend that a qualified person repair, replace or install siding or trim as necessary.

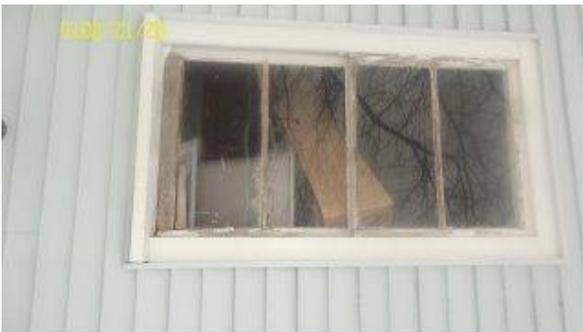
Photo 10-1

The paint or stain finish in some areas was failing (e.g. peeling, faded, worn, thinning). Siding and trim with a failing finish can be damaged by moisture. Recommend that a qualified contractor prep (e.g. clean, scrape, sand, prime, caulk) and repaint or restain the building exterior where necessary and per standard building practices. Any repairs needed to the siding or trim should be made prior to this.

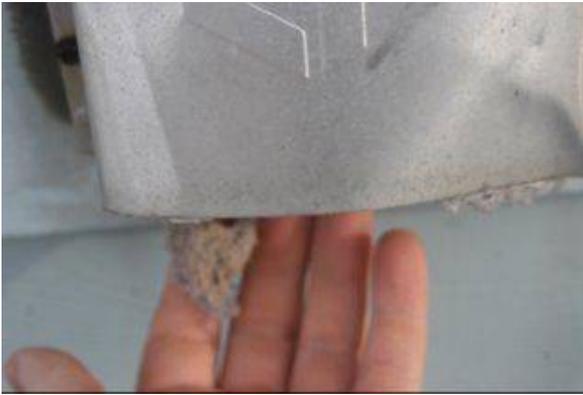
**Photo 11-1**

Clean and replace dryer vent. Dryer lint is a fire hazard, and dryer vents that do not have air flow activated baffles stay open and allow insects and vermin to enter a dwelling.

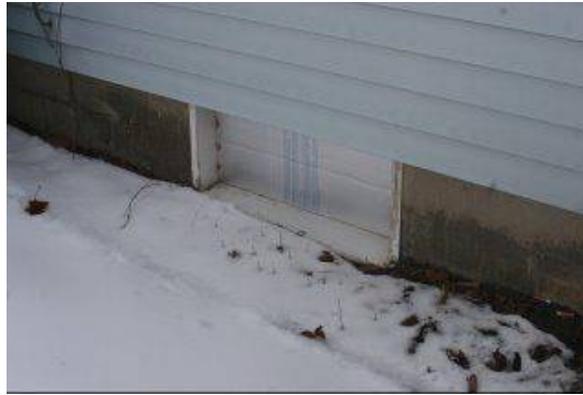
**Photo 11-2**

Basement windows are missing and should be replaced.

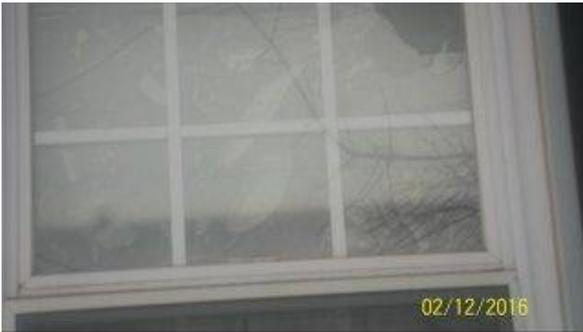
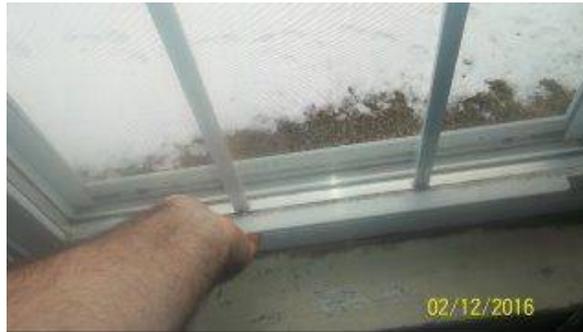
Windows are difficult to open and close.

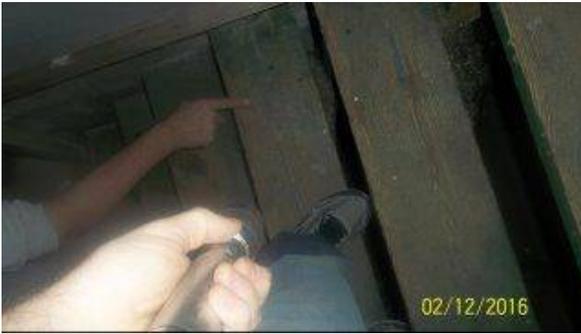
Photo 13-1

Risers for stairs at one or more locations were higher than 7 3/4 inches and posed a fall or trip hazard. Risers should be 7 3/4 inches or shorter. At a minimum, be aware of this hazard, especially when guests who are not familiar with the stairs are present. Recommend that a qualified contractor repair per standard building practices.

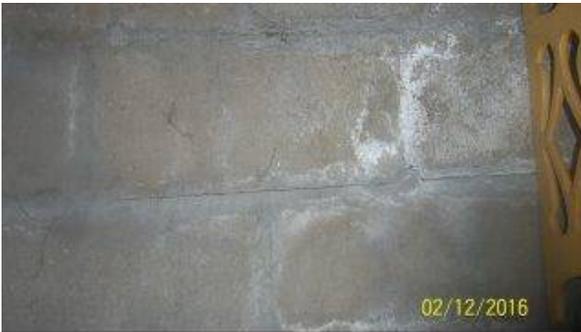
Photo 16-1

Evidence of prior water intrusion was found in one or more sections of the basement. For example, water stains or rust at support post bases, efflorescence on the foundation, etc. Accumulated water is a conducive condition for wood-destroying organisms and should not be present in the basement. Recommend reviewing any disclosure statements available and ask the property owner about past accumulation of water in the basement. The basement should be monitored in the future for accumulated water, especially after heavy and/or prolonged periods of rain. If water is found to accumulate, then recommend that a qualified contractor who specializes in drainage issues evaluate and repair as necessary. Typical repairs for preventing water from accumulating in basements include:

- Repairing, installing or improving rain run-off systems (gutters, downspouts and extensions or drain lines)
- Improving perimeter grading
- Repairing, installing or improving underground footing and/or curtain drains

Ideally, water should not enter basements, but if water must be controlled after it enters the basement, then typical repairs include installing a sump pump.

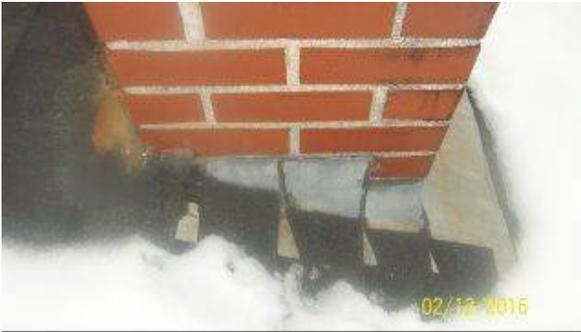
Photo 19-1

Flashings at the base of one or more chimneys were substandard. Leaks can occur as a result. This is a conducive condition for wood-destroying organisms. Recommend that a qualified contractor evaluate and repair as necessary.

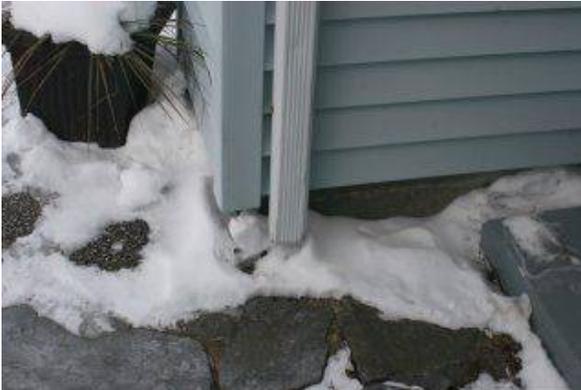
Photo 20-1

One or more downspouts or downspout extensions drained onto walkways. This can result in ice or moss forming on walkways, and can pose a fall hazard. Recommend that a qualified person install or modify extensions as necessary so rainwater isn't directed onto walkways.

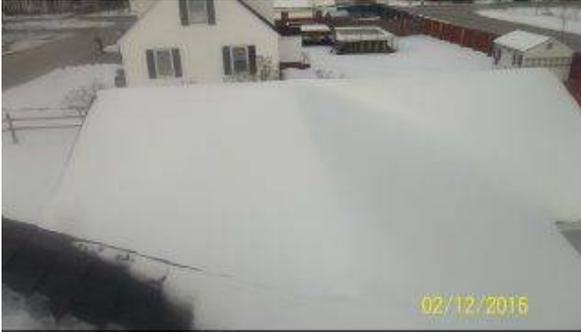
Photo 23-1

Some roof surfaces were obscured by snow and couldn't be evaluated. These areas are excluded from this inspection.

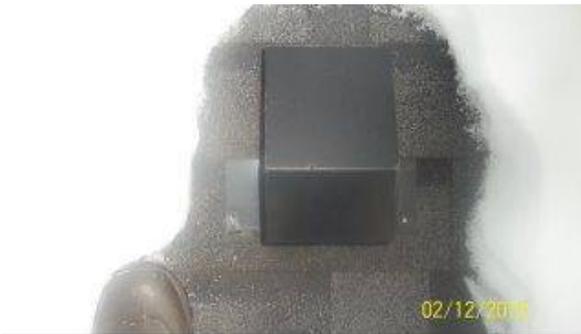
Photo 24-1

Fasteners are fastened through asphalt shingles, and could allow for water to penetrate the roof covering.

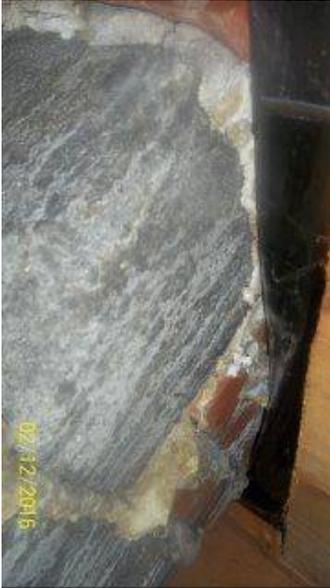
Photo 25-1

The roof structure in the attic was wet, and/or dripping water was found at one or more locations. There appeared to be one or more active leaks in the roof. Recommend that a qualified contractor evaluate and repair as necessary.

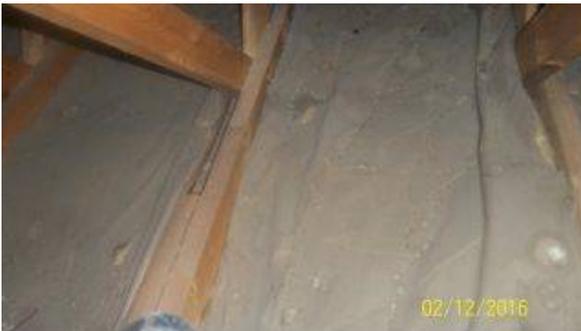
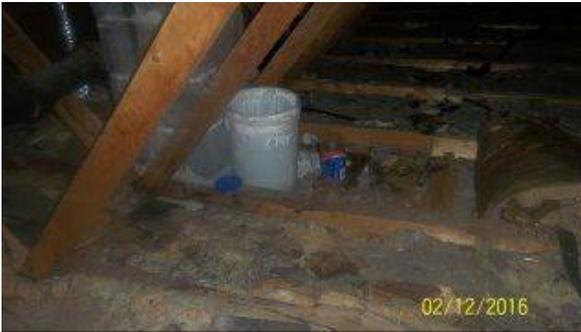
The ceiling insulation in one or more areas of the attic was compacted or uneven and/or missing. Heating and cooling costs may be higher due to reduced energy efficiency. Recommend that a qualified person repair, replace or install insulation as necessary and per standard building practices (typically R-38).

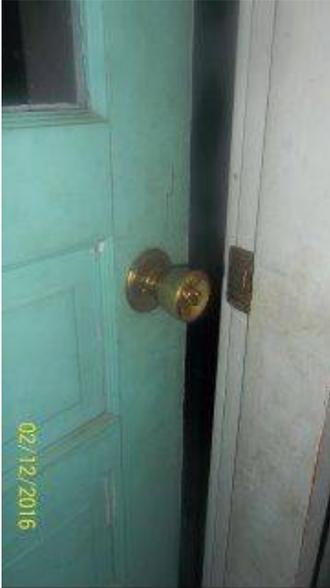
Photo 29-1

One or more exterior doors wouldn't latch. Recommend that a qualified person repair as necessary.

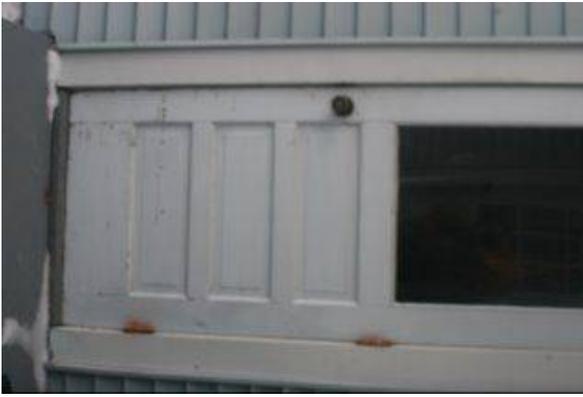
Photo 34-1

One or more exterior doors had minor damage and/or deterioration. Although serviceable, the client may wish to repair or replace such doors for appearances' sake.

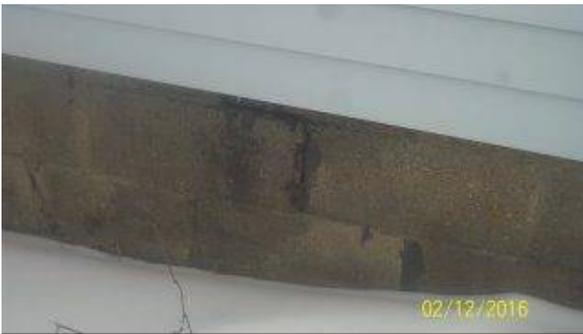
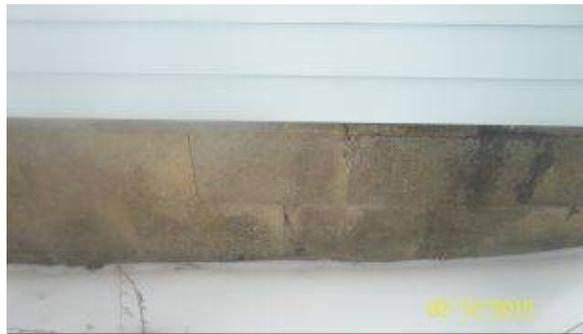
- 35) **i** Minor cracks were found in the concrete slab floor. These are common and appeared to be only a cosmetic issue.
- 36) **i** Some roof surfaces were obscured by snow and couldn't be evaluated. These areas are excluded from this inspection.
- 37) Foundation around the garage, has some cracks, holes and/or gaps. These do not appear to be a structural issue, but should be sealed appropriately.

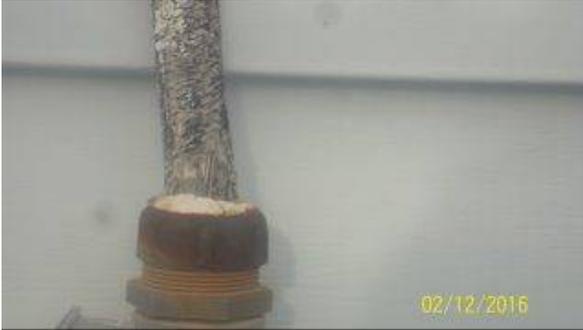
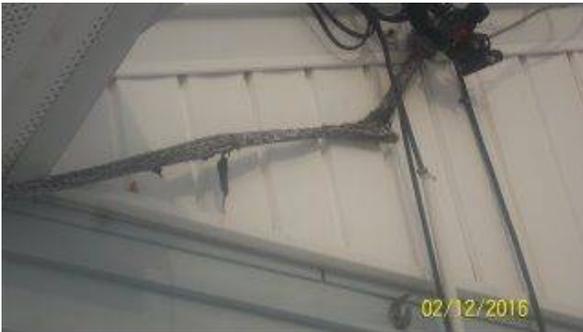
The service entrance wire insulation was frayed, damaged or deteriorated. This is a potential shock hazard. Recommend that a qualified electrician evaluate and repair if necessary.

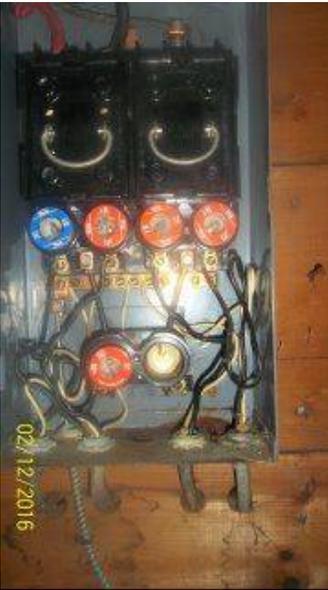
Photo 39-1

Panel(s) #A used screw-in fuses for the over-current protection devices. Fuses are prone to tampering and over-fusing, which can damage wiring and cause fire hazards. Insurance companies may deny coverage for homes with fused panels. Modern panels use circuit breakers for over-current protection devices, which can be reset easily after tripping rather than needing to replace fuses. Modern panels also offer more flexibility for new, safer protective technologies like ground fault circuit interrupters (GFCIs) and arc fault circuit interrupters (AFCIs). Consult with a qualified electrician about replacement options for fused panels, and about other system upgrades as necessary.

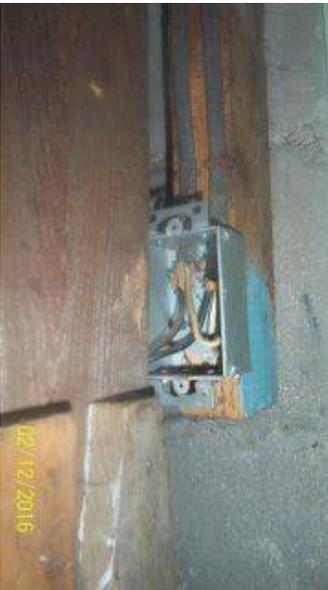
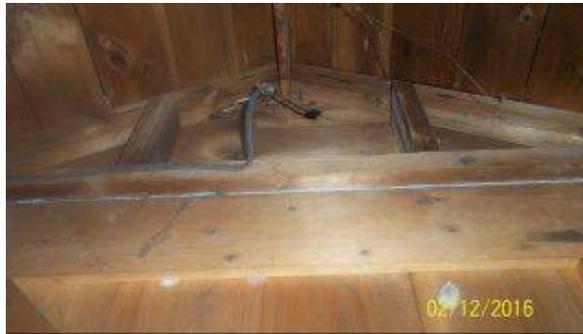
Wire splices were exposed and were not contained in a covered junction box. This is a potential shock or fire hazard. Recommend that a qualified electrician repair per standard building practices. For example, by installing permanently mounted junction boxes with cover plates where needed to contain wiring splices.

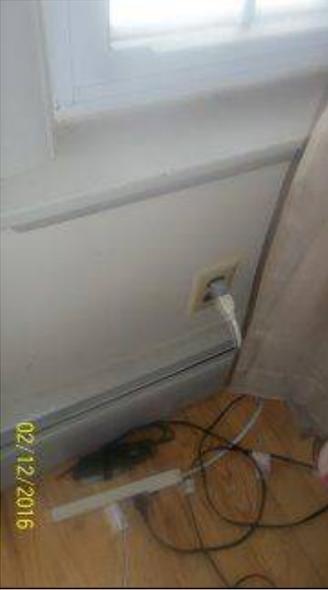
Photo 42-1

One or more modern, 3-slot electric receptacles (outlets) were found with an open ground. Three-slot receptacles should have a hot, a neutral and a ground wire connected. Homeowners often install new 3-slot receptacles on older, 2-wire circuits that only have hot and neutral wires. This is a shock hazard when appliances that require a ground are used with these receptacles. Examples of such appliances include computers and related hardware, refrigerators, freezers, portable air conditioners, clothes washers, aquarium pumps, and electrically operated gardening tools. Where the electric system was installed prior to when grounded circuits were required (1960s), it is permissible to replace 3-slot receptacles with 2-slot receptacles to prevent appliances that require a ground from being plugged in to an ungrounded circuit. However, the client should be aware of this limitation when planning use for various rooms, such as an office. For

newer electric systems, circuits should be repaired so grounded, 3-wire cables provide power to 3-slot receptacles. Recommend that a qualified electrician repair per standard building practices.

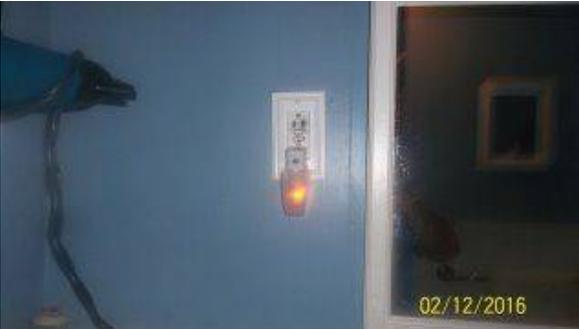
Photo 43-1

One or more ground fault circuit interrupter (GFCI) type receptacles (outlets) had an open ground. Open ground GFCI receptacles will trip, but they won't provide a grounded electric supply for appliances that need them. This is a potential shock hazard. Recommend that a qualified electrician repair per standard building practices. For example, by upgrading to grounded, 3-conductor wiring. In older dwellings constructed when GFCI protection was not required, and in areas where GFCI protection is not required, replacing 3-slot GFCI receptacles with 2-slot receptacles may be an acceptable repair.

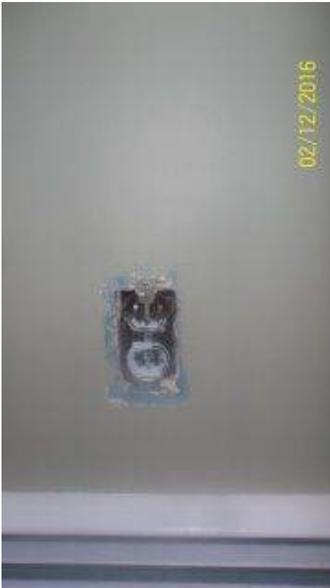
Photo 45-1

One or more cover plates for switches, receptacles (outlets) or junction boxes were missing or broken. These plates are intended to contain fire and prevent electric shock from occurring due to exposed wires. One or more receptacles were broken. Recommend that a qualified person install cover plates and replace broken receptacles where necessary.

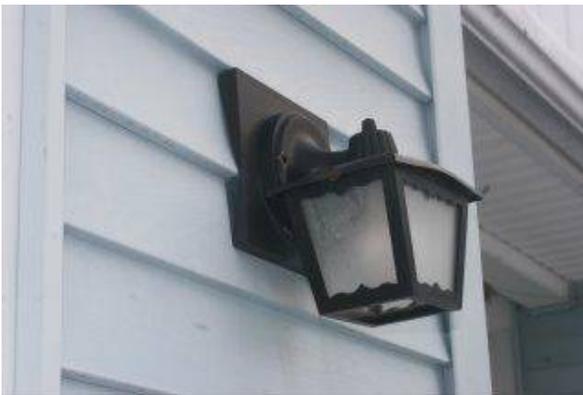
Photo 46-1

One or more wall-mounted exterior light fixtures had no caulk installed above the back plate. Water can enter the space behind the back plate and contact wiring. This is a potential shock hazard. Recommend that a qualified person apply caulk above and around the back plate per standard building practices. A gap should be left at the bottom of the plate so that condensation can drain out.

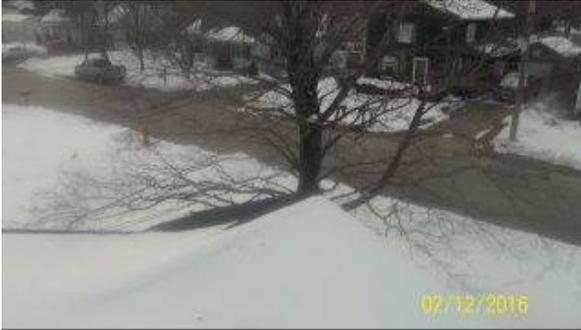
Photo 51-1

The service drop wires were in contact with trees or vegetation. This can result in damage to wiring insulation or broken wires during high winds. Recommend pruning trees or vegetation as necessary.

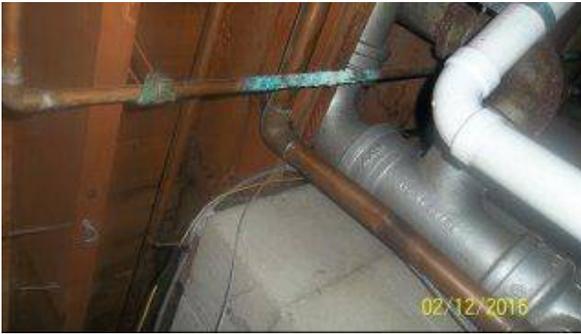
Photo 55-1

55) 🔧🔍 Significant corrosion was found in some water supply pipes or fittings. Leaks can occur as a result. Recommend that a qualified plumber evaluate and replace components as necessary.

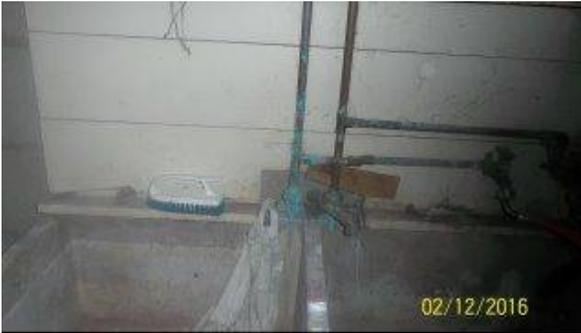
Photo 56-1

Significant corrosion was found in some pipes or fittings. This can indicate past leaks, or that leaks are likely to occur in the future. Recommend that a qualified plumber evaluate and repair as necessary.

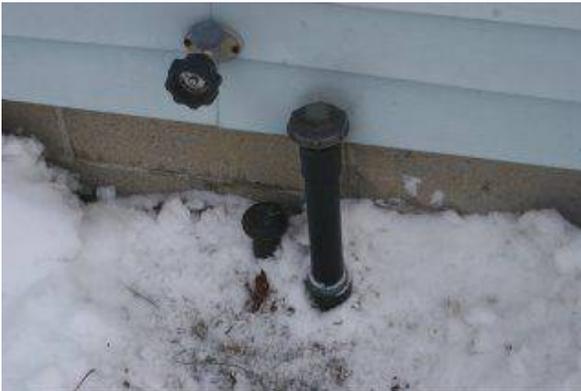
Photo 57-1

The oil storage tank fill and/or vent pipe terminated too close to a building opening. Fill and vent pipes should terminate at least 2 feet from any building opening, otherwise fumes can enter the building. Recommend that a qualified contractor or full-service oil company evaluate and repair as necessary.

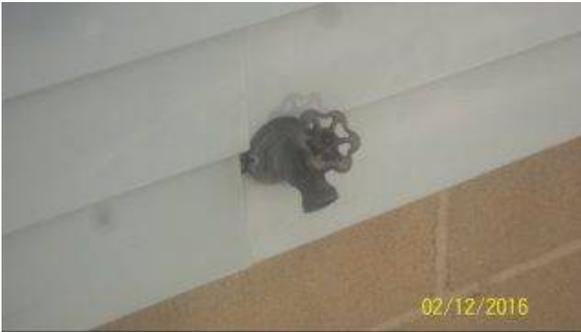
Photo 58-1

One or more hose bibs (outside faucets) were not the "frost-free" design, and are more likely to freeze during cold weather than frost-free hose bibs. Recommend that a qualified plumber upgrade these with frost-free hose bibs to prevent freezing, pipes bursting, flooding and possible water damage.

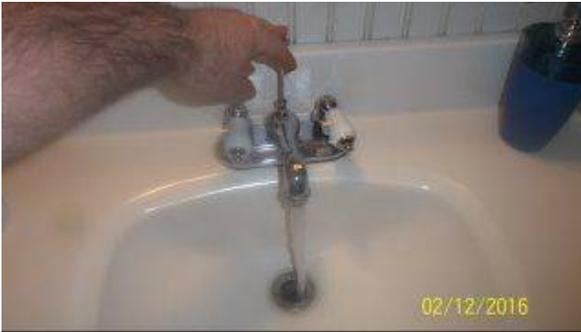
Photo 64-3

Drain stopper does not operate correctly.

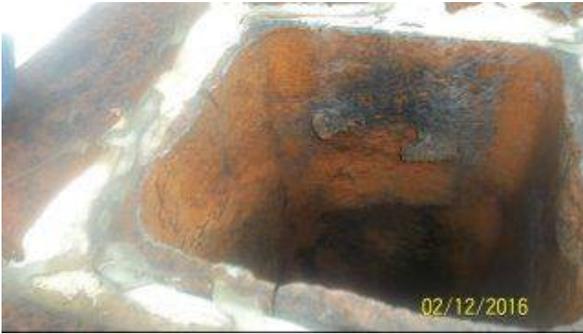
Photo 68-1

Terracotta flue tiles in one or more masonry chimney(s) were cracked or broken. This is a potential fire hazard because such cracks become wider when the chimney heats up and can allow exhaust gases to enter the building structure. Recommend that a qualified contractor evaluate, replace broken tiles and make other repairs as necessary.

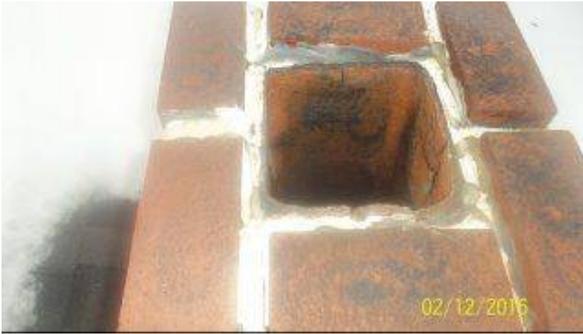
Photo 70-1

The brick chimney was moderately deteriorated. For example, loose or missing mortar, cracked, broken, loose or spalled bricks. Loose bricks can pose a safety hazard, and deteriorated masonry can allow water to infiltrate the chimney structure and cause further damage. Recommend that a qualified contractor repair as necessary.

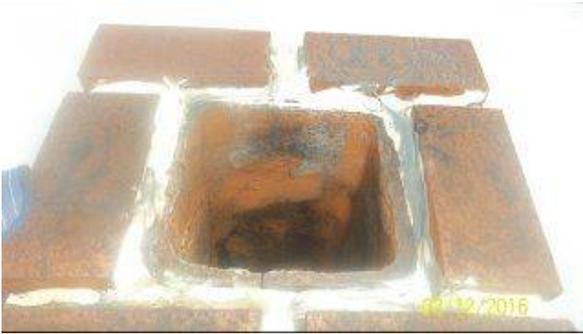
Photo 71-1

- Be constructed using either precast concrete slabs, cast-in-place steel reinforced concrete, solid stone, or metal
- Be sloped down from the flue a minimum of 3 inches of fall per foot of run
- Extend a minimum of 2 1/2 inches beyond the face of the chimney on all sides
- Not directly contact the flue liner (if installed), with the gap filled with flexible caulk
- Have flashing installed between the bottom of the crown and the top of the brick chimney

Recommend that a qualified contractor repair or replace crowns as necessary, and per standard building practices.

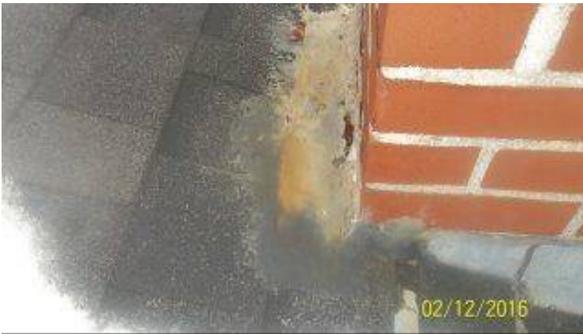
Photo 72-1

Gaps were found between the brick chimney and the building exterior. Recommend that a qualified person repair as necessary to prevent water, insect and/or vermin intrusion. For example, by installing or renewing caulk. Note that an approved material other than caulk should be used for gaps wider than 1/4 inch.

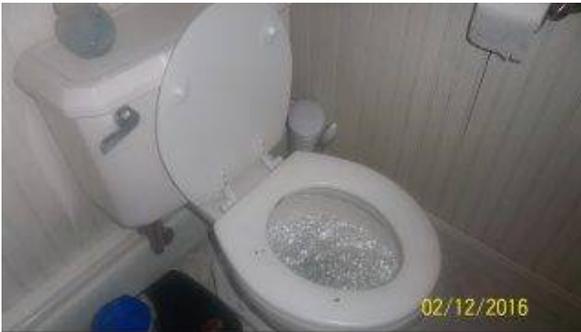
Photo 74-1

The handle for the toilet shut-off valve at location(s) #A was Hard to operate. Recommend that a qualified person replace or repair handles as necessary.

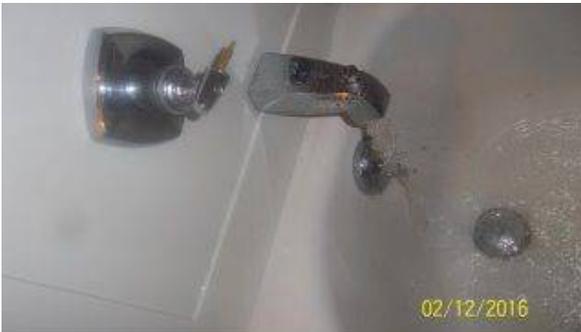
Photo 75-1

One or more bathtub faucet handles at location(s) #A were missing and/or loose. Recommend that a qualified person repair or replace handles as necessary.

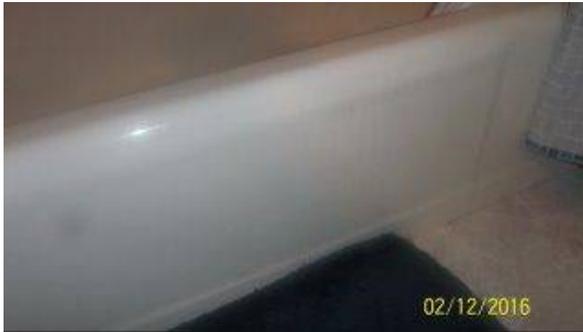
Gaps, no caulk, or substandard caulking were found between the bathtub and the floor and/or walls at location(s) #A. Water may penetrate these areas and cause damage. Recommend that a qualified person re-caulk or install caulking as necessary.

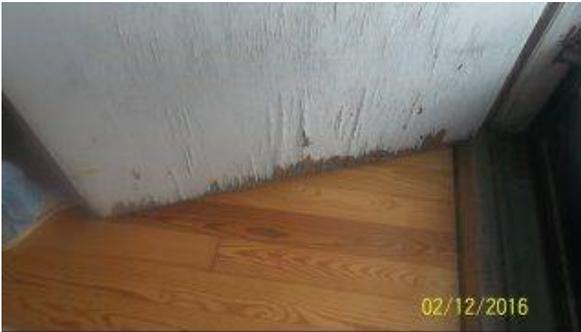
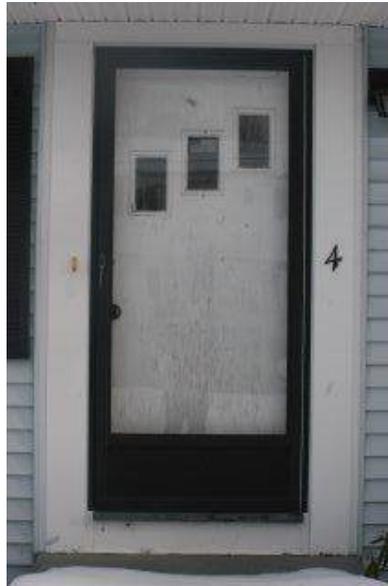
One or more exterior doors were significantly damaged or deteriorated. Recommend that a qualified person replace door(s) as necessary.

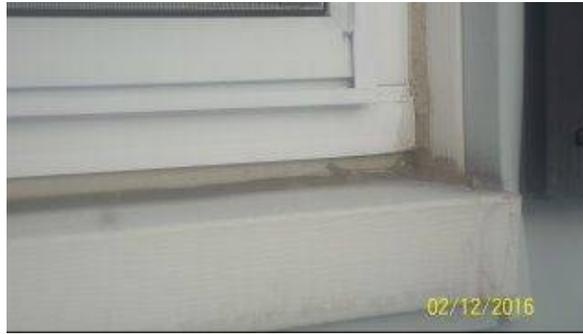
Photo X-2
Caulking around windows should be monitored and maintained regularly.

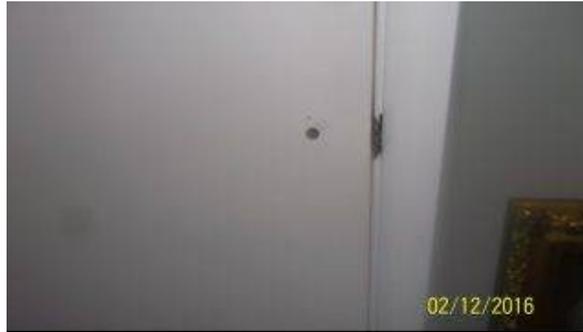
Photo X-4
Missing Door knob to closet door.
