WatchDog Inspectors

Property Inspection Report

Property address: **SomeStreet, Somewhere.**

Inspection date: **Friday, February 12, 2016**

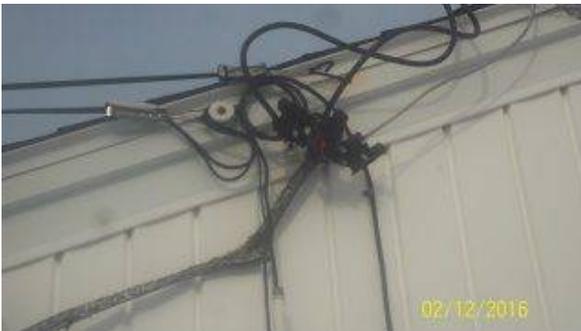
Photo 54-1

There does not appear to be a drip loop. Water could potentially run down a service entrance wire and enter the electrical box.
